Job Reference: VSN: 15499 : Issue 1

Customer: Bowman Stor

Test Ref: Shaker Hire

Based on IEC 61373-2010 Cat 1 Class B, In accordance with IEC 60068-2-27:2008 & IEC 60068-2-64.

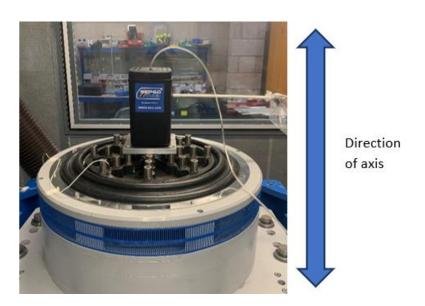
Z axis:

After the completion of testing, no imperfections of cracks were found on the customers product. During the endurance testing the three-phase on the amp tripped causing a delay in the testing, this was soon fixed

but caused the testing to run over to the next day. The jig was then unbolted from the armature and the shaker was rotated ready for the next axis of testing.

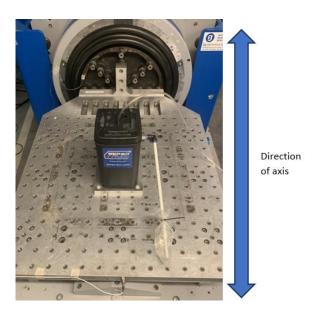
X axis:

After test completion, no imperfections or cracks were found on the customer product. The functionality testing had some problems in horizontal due to the low acceleration levels, causing the accelerometers to pick up some background electrical noise from the shaker and tripping the test. The customer was contacted about this issue and the acceleration was increased so that the shaker could run the test. Testing was then continued until completion and the jig was rotated, ready for the next axis of testing.

- During the functionality testing in the X axis, it was found that the accelerometer cable had became worn at some point during the test and caused the graph to display a high amount of noise. This cable was quickly replaced, and testing was restarted.
- After the mixture that the customers provided had ran out, a mixture of oil and water was used instead during the functionality test.
- Revision 2 report to include reference to IEC 60068-2-27 & -64:2008. Plus, reference to IEC 61373-2010 acceptance criteria.

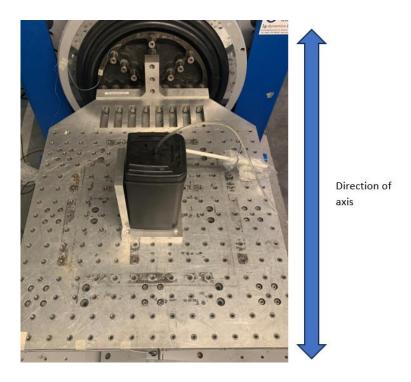
Y axis:

After the testing had been completed, the customer product was inspected for any signs of cracks or imperfections. The product was unbolted from the test jig and prepared for collection by the customer the following day.
